## Duck Creek

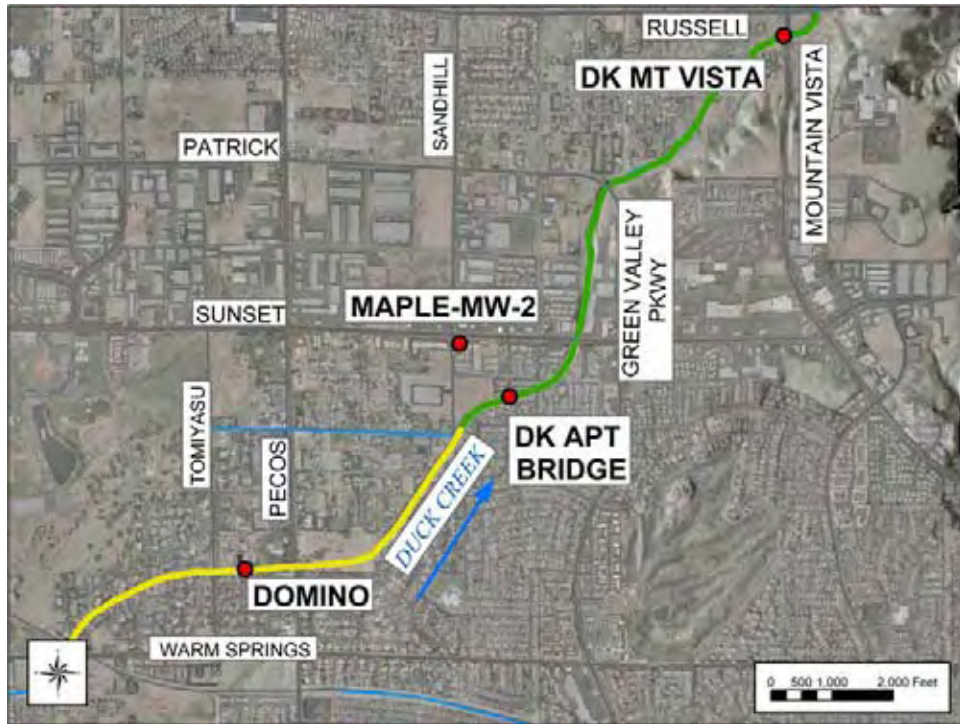
**Figure 3. Map detailing sampling sites along Duck Creek. The Domino site is the start of perennial flow in Duck Creek. Lined channel highlighted in yellow, natural channel highlighted in green.**

Within the area of this investigation Duck Creek is a perennial stream. The channel has a concrete liner from Warm Springs Road, northeast to the end of Sandhill Road (Figure 3). The concrete liner was recently installed for erosion control due to the periodic flooding, which occurs in this channel. The presence of a concrete liner inhibits the evaluation of groundwater contribution along reaches and limits the expected interaction. From the end of Sandhill Road, northeast to Patrick Lane, the channel is an engineered culvert lined with loose rock for erosion control. Below Patrick Lane, the channel is a natural stream incised approximately 15 feet below the surrounding grade. The bank material is composed of fine grained sands and silts. Initial investigations were conducted during a period of dry weather flow.

lower reach. The down gradient site is located at the Mountain Vista bridge near Russell Road (DK MT VISTA, Figures 3 and 7). Preliminary investigation along this reach of Duck Creek indicated that additional sites would be required to assess the effects in other geographic areas.

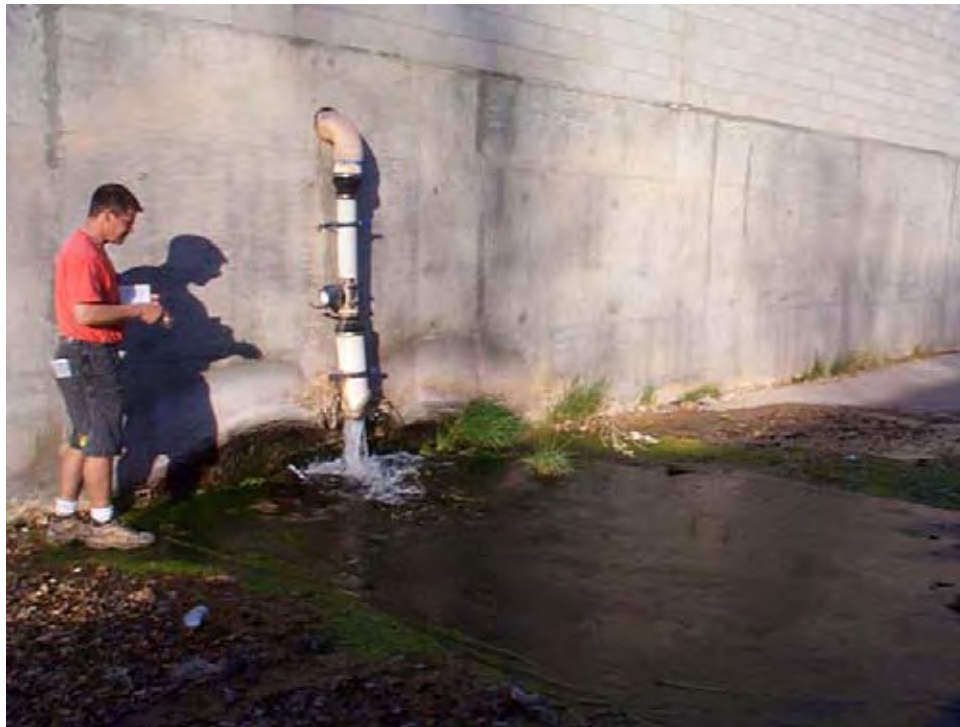
**Figure 4. Photo of the Domino Estate dewatering outfall. This outfall functions as the start of perennial flow in Duck Creek.**

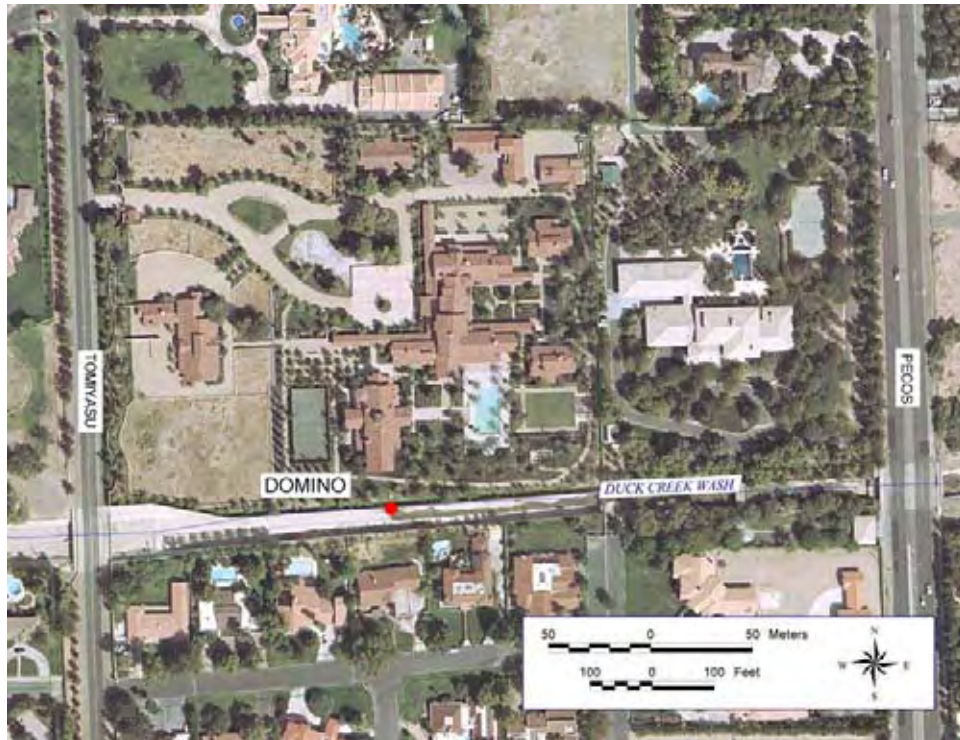
Figure 5. Map detailing the Domino Equestrian Estate dewatering site. This outfall functions as the start of perennial flow in Duck Creek.

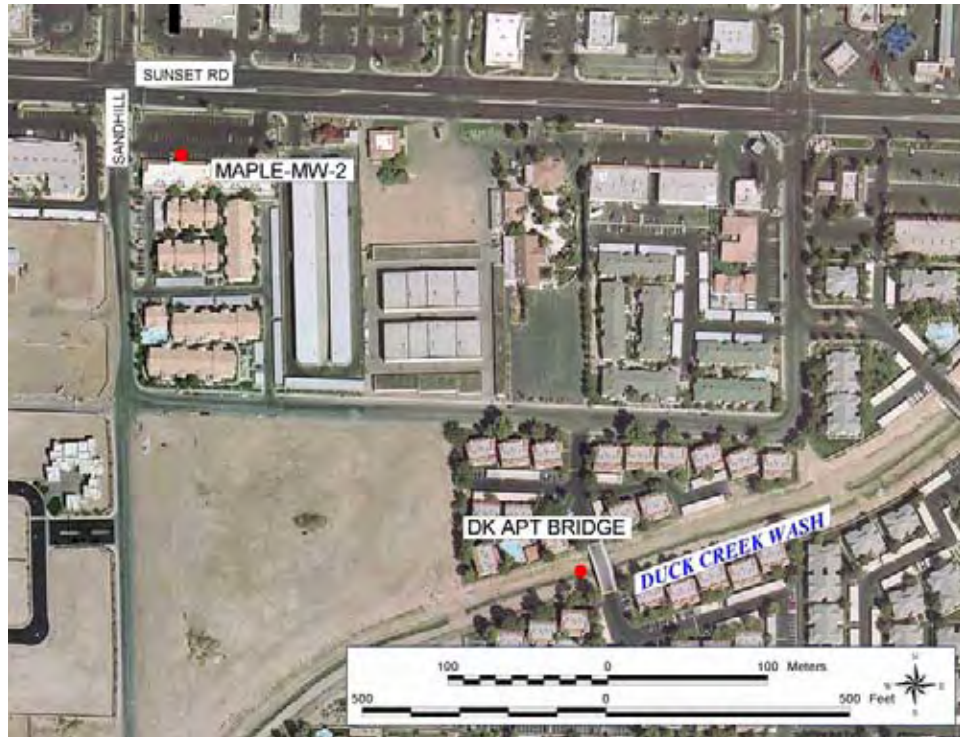
Figure 6. Map detailing location of Maple-MW-2 and the sampling site along Duck Creek under the apartment bridge.

The Domino discharge site was selected as a starting point for characterization of the surface flow of Duck Creek and as a possible area of ISDS influence. A second sample site, DK APT BRIDGE, was selected approximately  $\frac{1}{4}$  mile down stream from the end of the lined channel near an unnamed bridge in an apartment complex (DK APT BRIDGE, Figure 6). This site is in close proximity to an area of numerous ISDS and is below a reach of the stream influenced by shallow groundwater. An EC increase from 4310 to 4540  $\mu\text{S}/\text{cm}$  and a change in flow from 70 to 300 gpm strongly indicated that shallow groundwater was contributing to the channel in the reach between the end of the lined portion of Duck Creek and the apartment bridge. After the initiation of regular sampling, monitor wells were discovered at Maple Cleaners near the corner of Sunset and Sandhill Road. Maple MW-2 is at the site of a Perchloroethylene (PCE) release and subsequent remediation with a clean site closure in 1998 (NDEP site No. H-001037). Downstream of DK APT BRIDGE, Duck Creek passes another area of high ISDS density, between Patrick Lane and Russell Roads to the north and south, bounded by Pecos Road to the west and Duck Creek to the east. DK APT BRIDGE functions as the up-gradient site for the

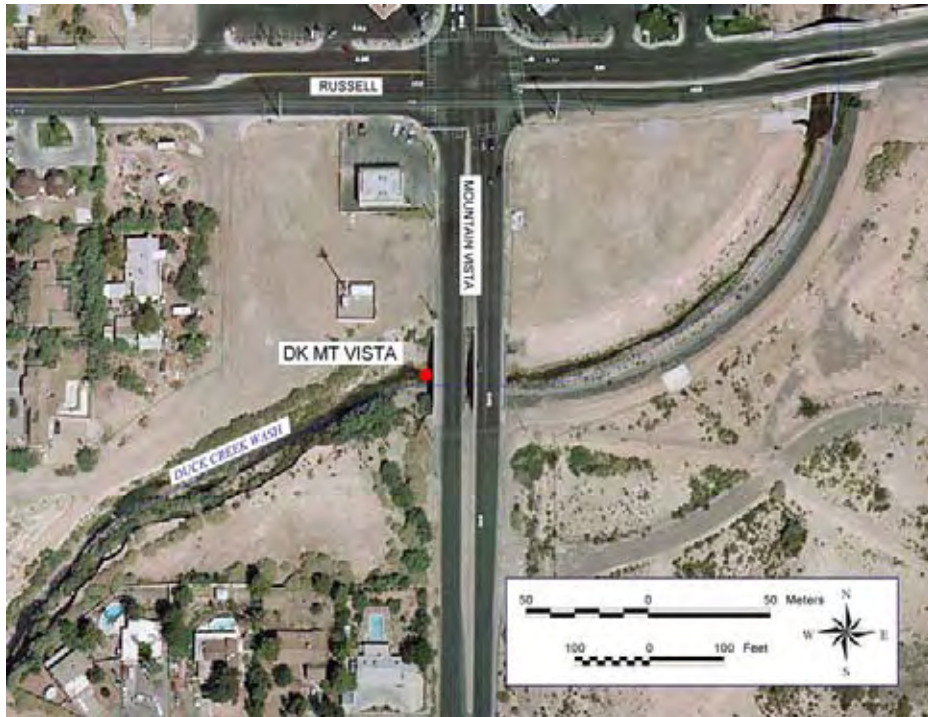
**Figure 7. Map detailing the location of the Duck Creek sampling site below the Mountain Vista bridge.**
