## **Flamingo Wash**

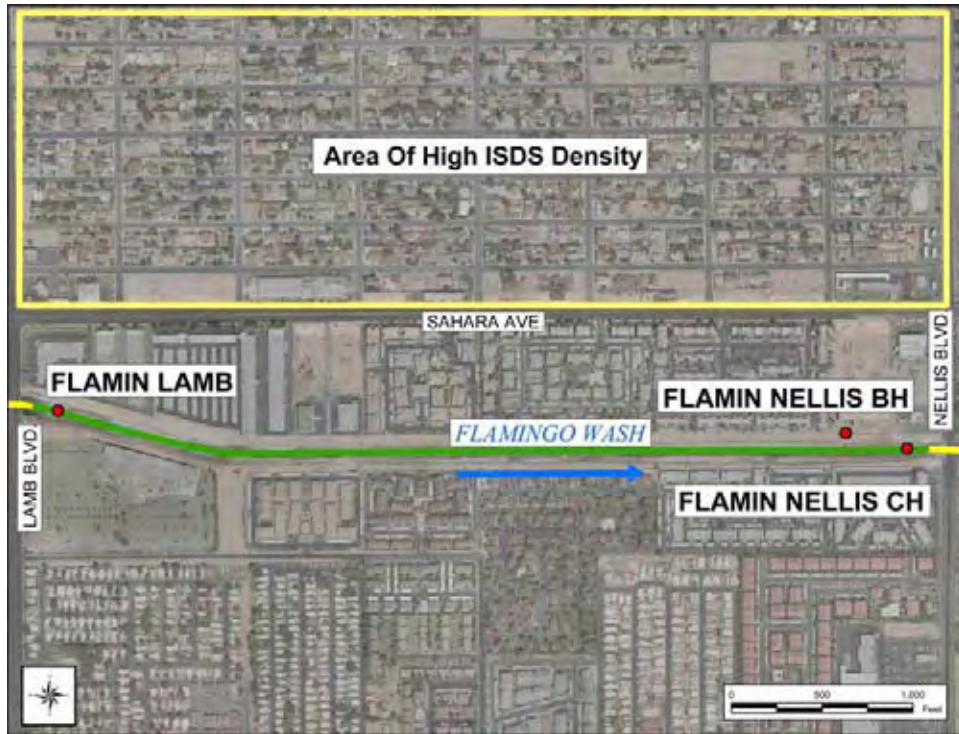
Figure 8. Map detailing locations of surface water sampling sites and borehole along reach of Flamingo Wash. Area of high ISDS density is in the north portion of the map. Many of the parcels located north of Sahara have registered ISDS. Lined channel highlighted in yellow, natural channel highlighted in green.

Flamingo Wash and Sloan Channel were selected as additional areas of likely influence. A reach of Flamingo Wash between Lamb Blvd. and Nellis was selected based on the close proximity of a ISDS high density area north of Sahara (Figures 2 and 8). The channel between Lamb and Nellis is a natural material culvert with concrete weirs for grade control near Lamb Blvd.. Field investigation revealed an increase in EC from 3270 to 3440  $\mu\text{S}/\text{cm}$  without significant surface contributions. An increase in EC suggests a contribution from shallow groundwater. An up gradient sample station was selected below an erosion control structure near Lamb Blvd. (FLAMIN LAMB, Figures 8 and 9). A down gradient sample station for this reach was selected just upstream of Nellis Blvd (FLAMIN NELLIS, Figures 8 and 10). This site was selected to intercept surface water prior to exposure to reuse water, which is used for turf irrigation at the Desert Rose golf course. No suitable monitor wells were found in proximity to the wash or the ISDS area; therefore, an exploratory borehole was hand augered adjacent to the Flamingo Wash to determine if shallow groundwater exhibited a chemical makeup distinct from that in the channel (FLAMIN NELLIS BH, Figures 8 and 11).

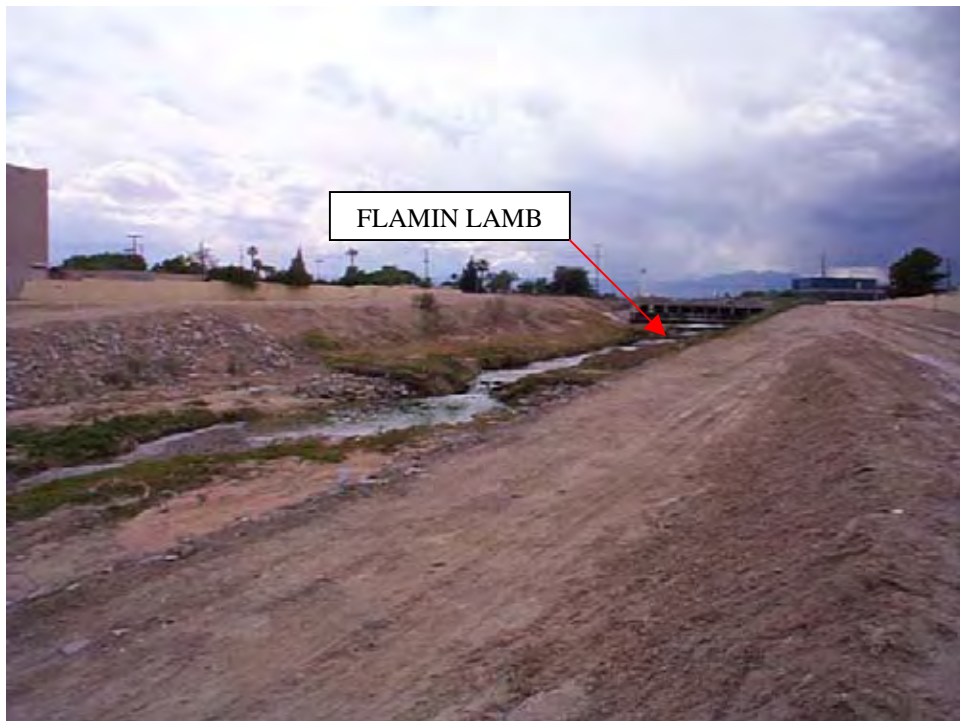
Figure 9. View facing west detailing location of Flamingo Wash sample site at Lamb Blvd. (FLAMIN LAMB).

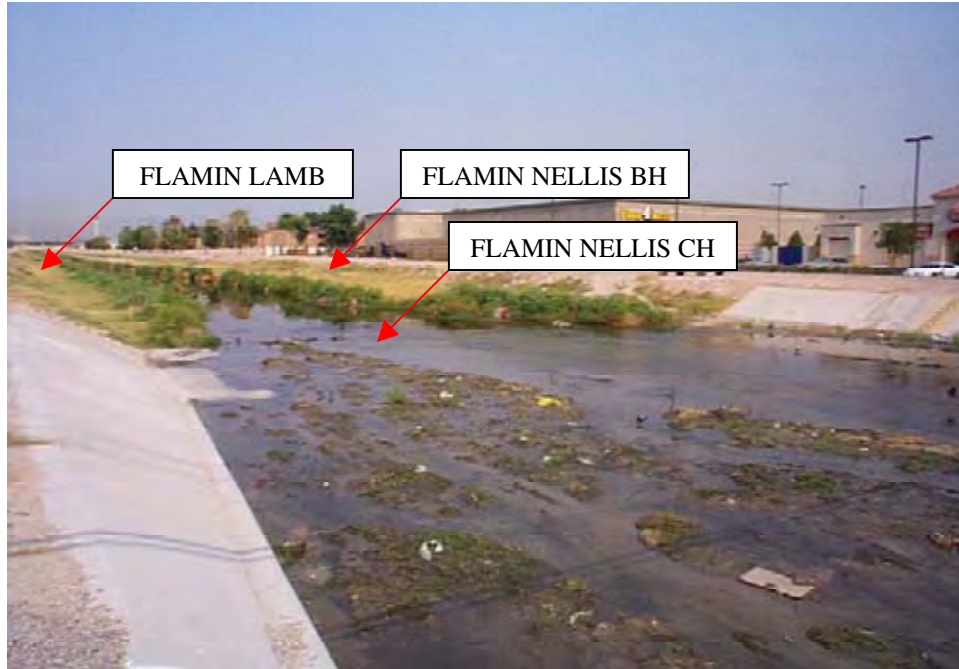
**Figure 10. View facing northwest detailing the sampling site on Flamingo Wash above Nellis (FLAMIN NELLIS CH) and the location of the borehole adjacent to the channel (FLAMIN NELLIS BH).**

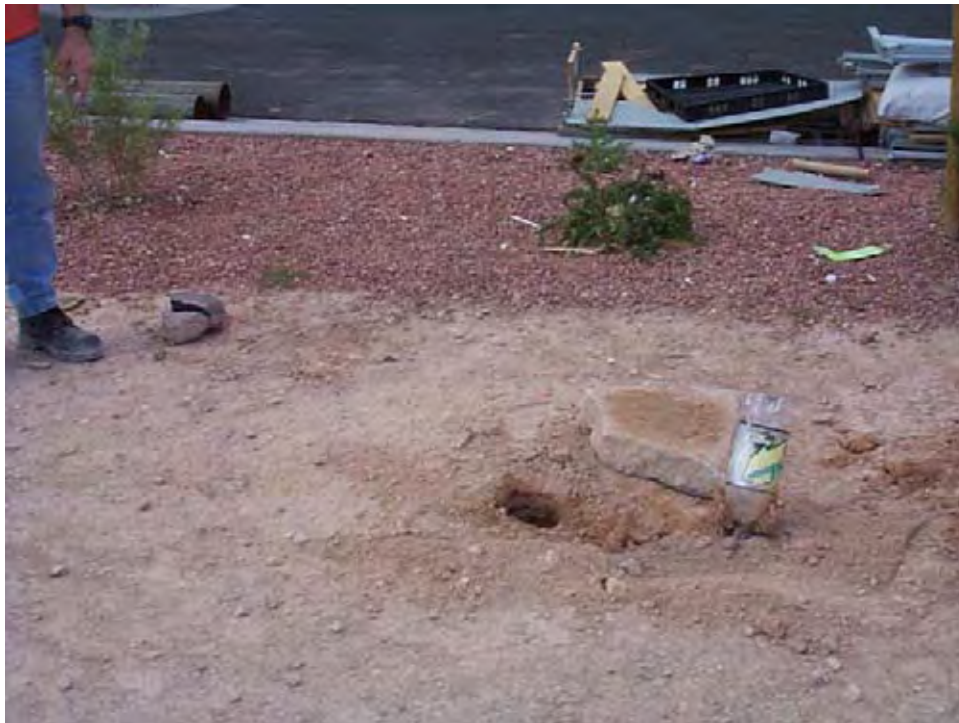
**Figure 11 Photo detailing the borehole near Flamingo Wash at Nellis (FLAMIN NELLIS BH).**
